## ABUSE READY!

## Abuse Ready!

## Test details

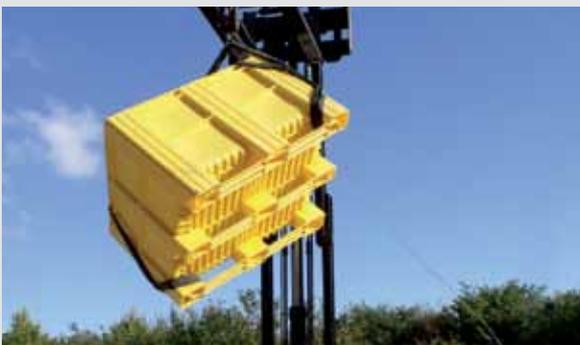
#### **DROP TEST**

After a 3-metre drop onto concrete, only the Dolav was undamaged

From three metres high products were dropped onto their top and bottom corners on to a concrete surface. Closely examined and photographed for damage or lack of it afterwards each box was scrutinised. Cracks appeared in all the competitive products. Only the Dolav 1000 Ace was undamaged.

**Drop Test results - Dolav:** “Scuffing only observed”

**‘Others’:** “Bottom corner runner cracked”, “runner partially dislodged”, “crack to corner where runner locates”. *All drops were performed onto concrete.*

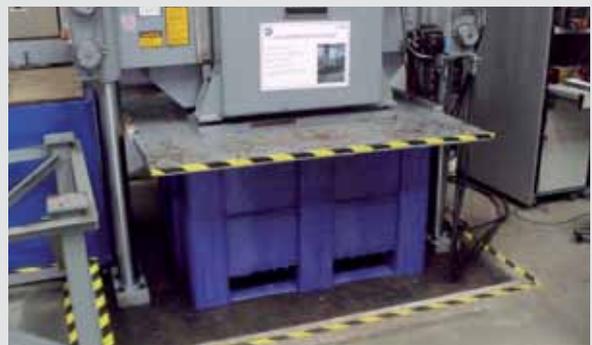
#### **LOAD TEST**

Dolav recovered when the load was released... corner pillars remained fully supportive

Some products showed catastrophic failure with severe overloading. While all the products tested performed correctly within their published bottom-load specifications with progressively increased 'real world overloading', distortion occurred on each to different extents. Amazingly, the Dolav 1000 Ace shows only some modest central rib depression at maximum compression which self-corrected when released. The test report states, "The Dolav pallet box corner pillars remained fully supportive at the machine's maximum compression." That was at a loading too high to be achieved in use. These load tests used the largest compression machine in Europe which has a maximum compression of 13.6 tonnes.

**Compression / load Test results - Dolav:** Shows a wavy undulation to the pallet box at 10000kgf (22000lbf), which fully recovered when the load was released ... the pallet box corner pillars remained fully supportive at the machine's maximum compression

**'Others' included:** "... some buckling of the pallet box as the load increased which mainly recovered when load removed"; "... buckled significantly as load increased ... mostly recovered ... permanent damage to sides visible, test stopped at 12022kgf (26449lbf)" and some buckling recovered when load removed ...

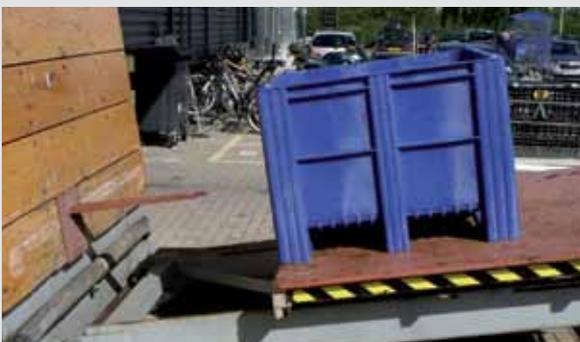
#### **IMPACT TEST**

The Dolav was least affected. All were marked. Two were penetrated.

Spiked! Many plastic boxes are penetrated by the forks on fork lift trucks. They have a small area at the point and so when driven at even slow speed into the side of a plastic pallet box the point pressure can be high and break through the plastic wall or at least cause an obvious indentation and weakness. Each product, with the same 500kg load of lead acid batteries, travelled down a slope angled at 88 degrees to be potentially impaled on a single fork tine. One was penetrated. All were marked. The Dolav was least affected.

Fork tine impact test results – Dolav: With 500kg load, shows the slight indentation upon impact with the side of the pallet box.

Others: With 500kg load, "Tine impacted side ... left deep indentation, and on two: "tine pierced through ... on impact".

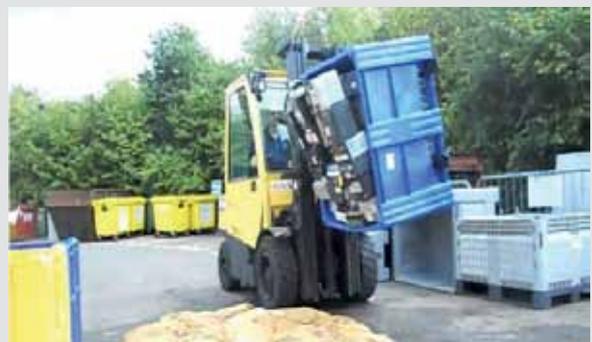
#### **ROTATING FORK TEST**

Dolav moulded-in runners withstood the force. No damage observed to the Dolav.

**Rotating fork test - Dolav:** "The pallet did not adversely bend at its side face ... the moulded runners withstood the force at its highest point."; "No damage observed to the base of the pallet box following the rotational test."

**Another:** "pallet box flexed outwards at its side ... runners bent ... runner lugs partially un-located from their snapped-in positions."

Pallets rotated on truck forks rely on their runners and side wall strength. In this test the load was 900kg of used car batteries within the Dolav Ace rotated through 180° and tipping out all of the contents. Maximum loading occurs just before tipping out the load as most of the weight is on one end wall and all of the weight is taken by the runners and legs. With the Dolav Ace the pallet box did not adversely bend the end wall, the one-piece, integrally-moulded runners withstood the force at its heaviest point and the box show no damage. Test observations on a competitive product, by contrast, were less positive and included, "pallet box flexed outwards at its side ... runners bent ... runner lugs partially un-located from their snapped-in positions." It met spec but not application.
